ERDC/CERL TR-01-57

Underground Storage Tank Location and Mapping of Former Landfills by Electromagnetic Surveys for the Delaware National Guard

August 2001

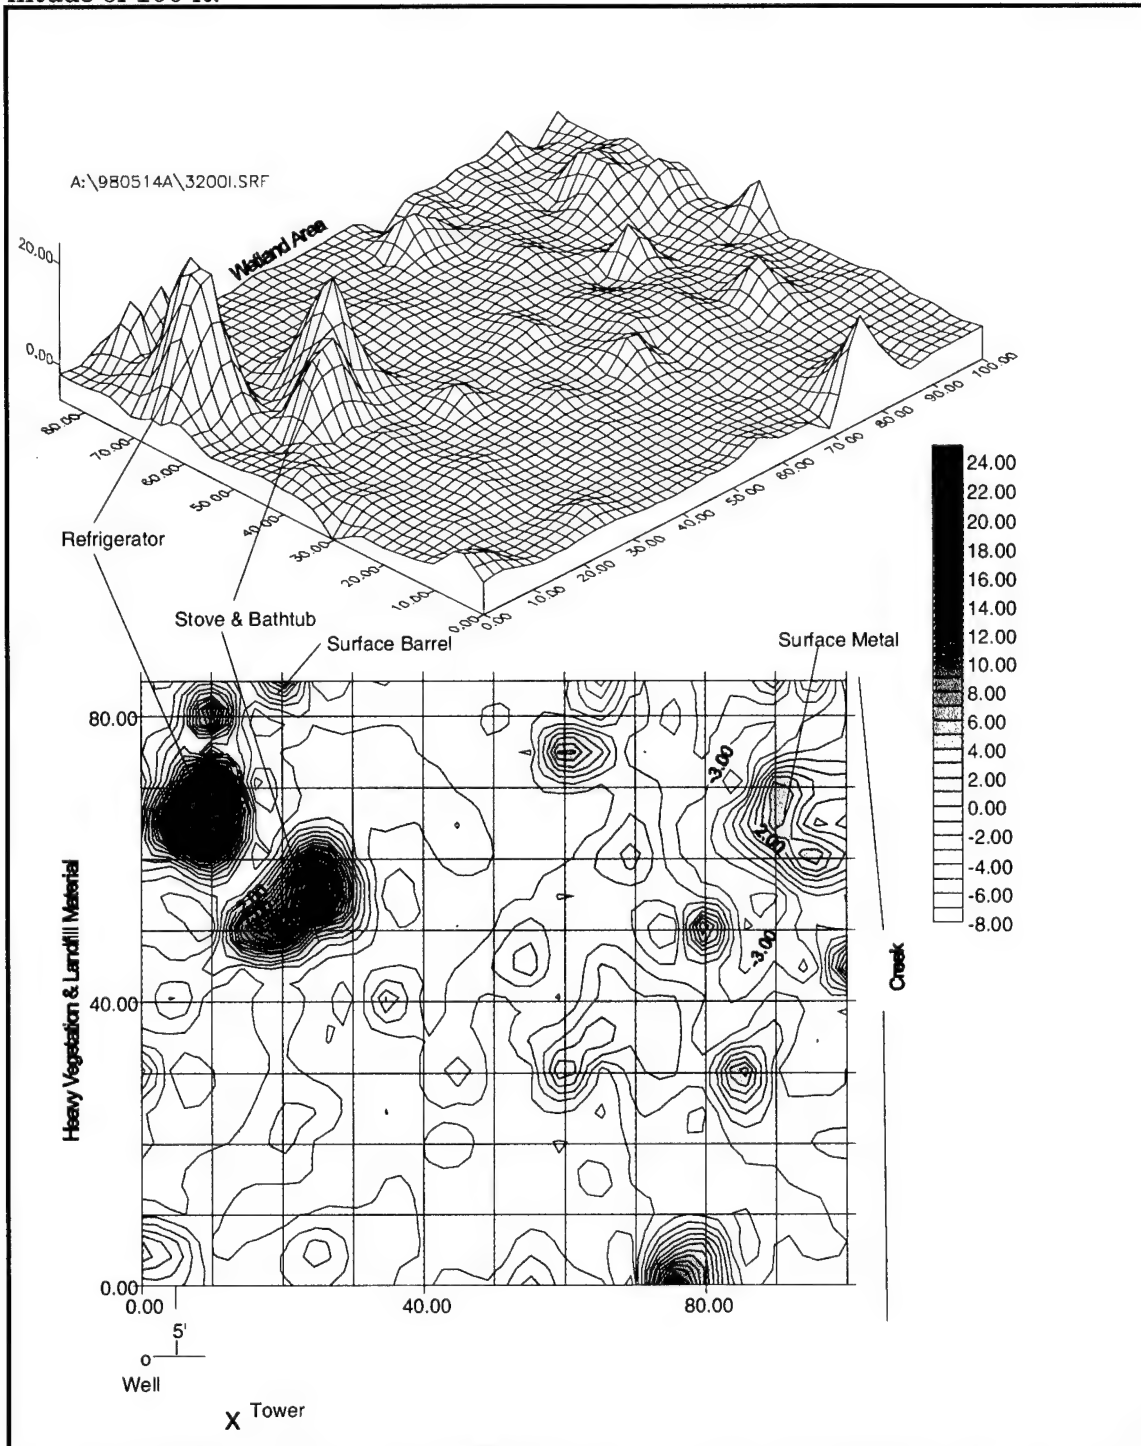
Location 8 is situated to the upstream river side of the watchtower near the tower. Figures 2 and 15 show its approximate location and orientation. It is more or less bounded by a heavily vegetated area with considerable surface metal and other landfill type materials on one end, the creek on the other end, and the creek and wetlands on one side. Figure 20 shows the results of this survey. Several large metallic items (labeled in Figure 20) were found on the surface in this area (Figure 21). The remainder of the plot indicates possible random relatively small metal items such as would exist in a landfill area.

Figure 20. Electromagnetic survey results, 3200 Hz, in-phase data, location 8, Watchtower area.

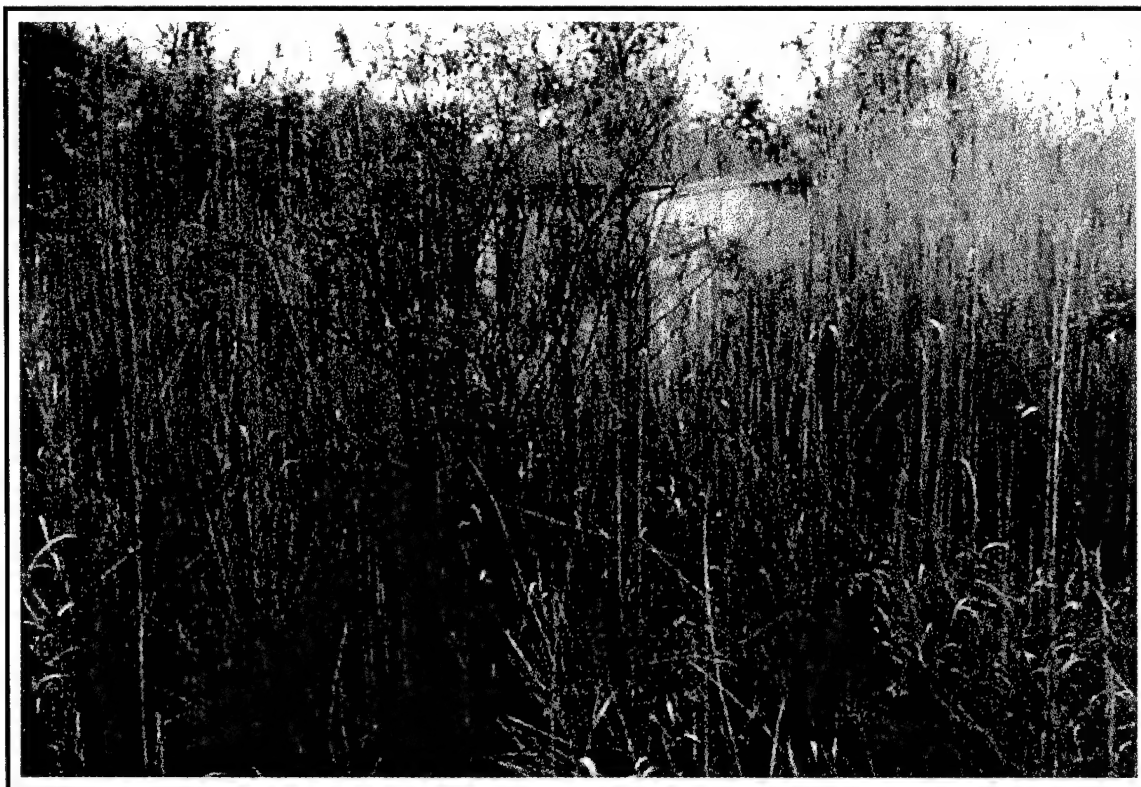
Figure 21. Surface metal item and dense vegetation in the watch tower area, New Castle Rifle Range, DE.

The surveys at the New Castle Rifle Range were all conducted on a point-by-point basis with the GEM-1. Heavy vegetated areas (Location 1 and parts of the watchtower area) were difficult to survey due to the difficulties of traversing and of maintaining accurate data point location. Significant quantities of large surface metal were also present (Figures 20 and 21) in much of the watchtower area (Locations 6 – 8). Surface metal masks buried objects and decreases the value of the data in areas where it is present. If a more detailed electromagnetic survey of the watchtower area is necessary, it is recommended that all the surface metal be removed from the area and a survey be conducted in the winter when the vegetation may be less of an impedance. (Even in winter, considerable areas will remain inaccessible unless the vegetation is thinned. This data can be used for removal of individual buried items, however due to the grid spacing used and the dimensions of the sensor, the item may not be exactly at the location shown on the plots. If removal of individual buried items is desired, final location of the items can be done with electromagnetics (GEM-1, GEM-300, or Geonics EM-31), or possibly with a handheld magnetometer since it is likely that most such items are ferrous metal. It is also recommended that Coast Guard rebroadcast GPS location be used for placing of search areas. This signal allows accuracy to

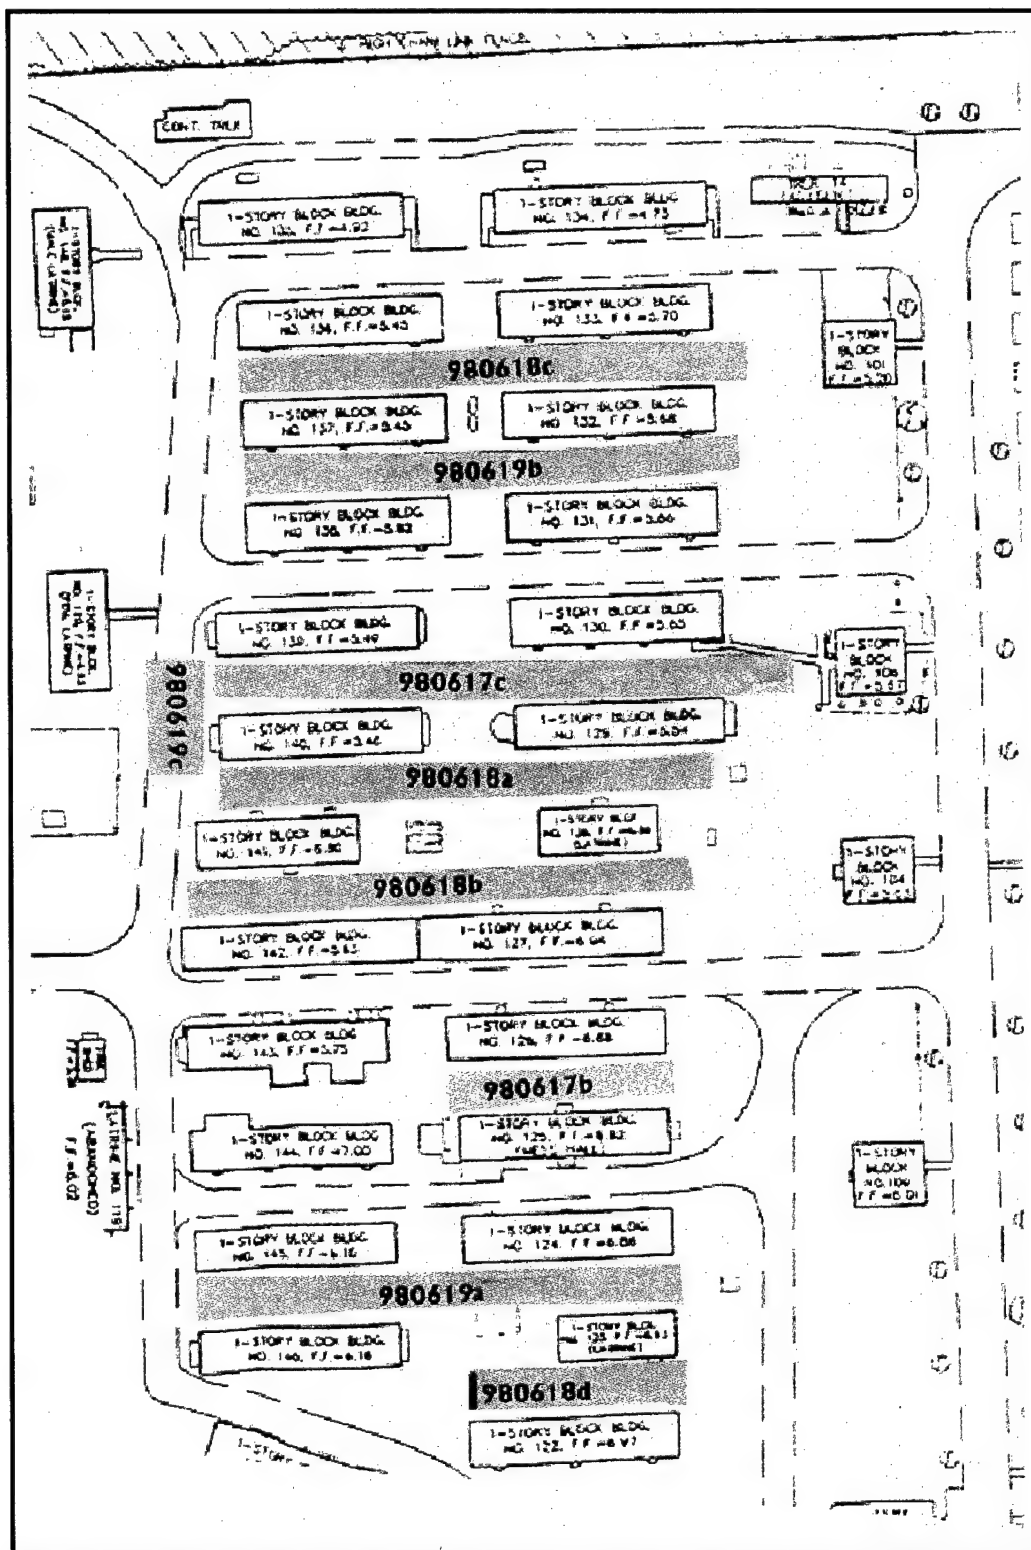
Figures 22 and 23 show the locations of the survey areas for this study. Figure 22 identifies the areas among the barracks, primarily between rows of buildings. The buildings in this area are cinder block (probable vintage WWII) with an insulating stucco-type finish on the outside. They are typically 20 ft wide and 40 to 100 ft long. Separation between the buildings is typically 30 ft. The buildings contain interfering metallic objects such as bunk beds and refrigerators. In addition, some air conditioners, barbecues, satellite antennas, picnic benches, and propane tanks were found in or near the areas to be surveyed. An underground tank had been discovered when additions were built onto Buildings 143 and 144. The surveys among the barracks were conducted to locate similar items or to verify that the area was clear. There is a concrete structure on the east side of Building 148 (the men's latrine), identified by a retired individual camping on the installation, as a coal bin for "bucket a day" coal stoves. According to his description, a person was assigned to each coal stove to supply it with coal for each day. Although no evidence of the coal stoves exists today, it is logical to assume that they could have been used in the barracks for heat and thus there would be no buried storage tanks for fuel oil associated with the barracks.

Figure 22. Electromagnetic survey locations at the barracks area, Delaware National Guard Training Site, Bethany Beach, DE (bold type identifies data file names).

Individual search areas are identified by the sequence in which they were completed. The designations include the date and the sequence of survey taken on that date. Thus, 980619a is the first survey (a) conducted in the year 1998 (98), month June (06), day (19). These designations are used as data file names to aid in recordkeeping. An additional area, not directly between rows of buildings (980619c) was surveyed to provide more detail when a suspected subsurface object was identified on the south end of the area 980617c.

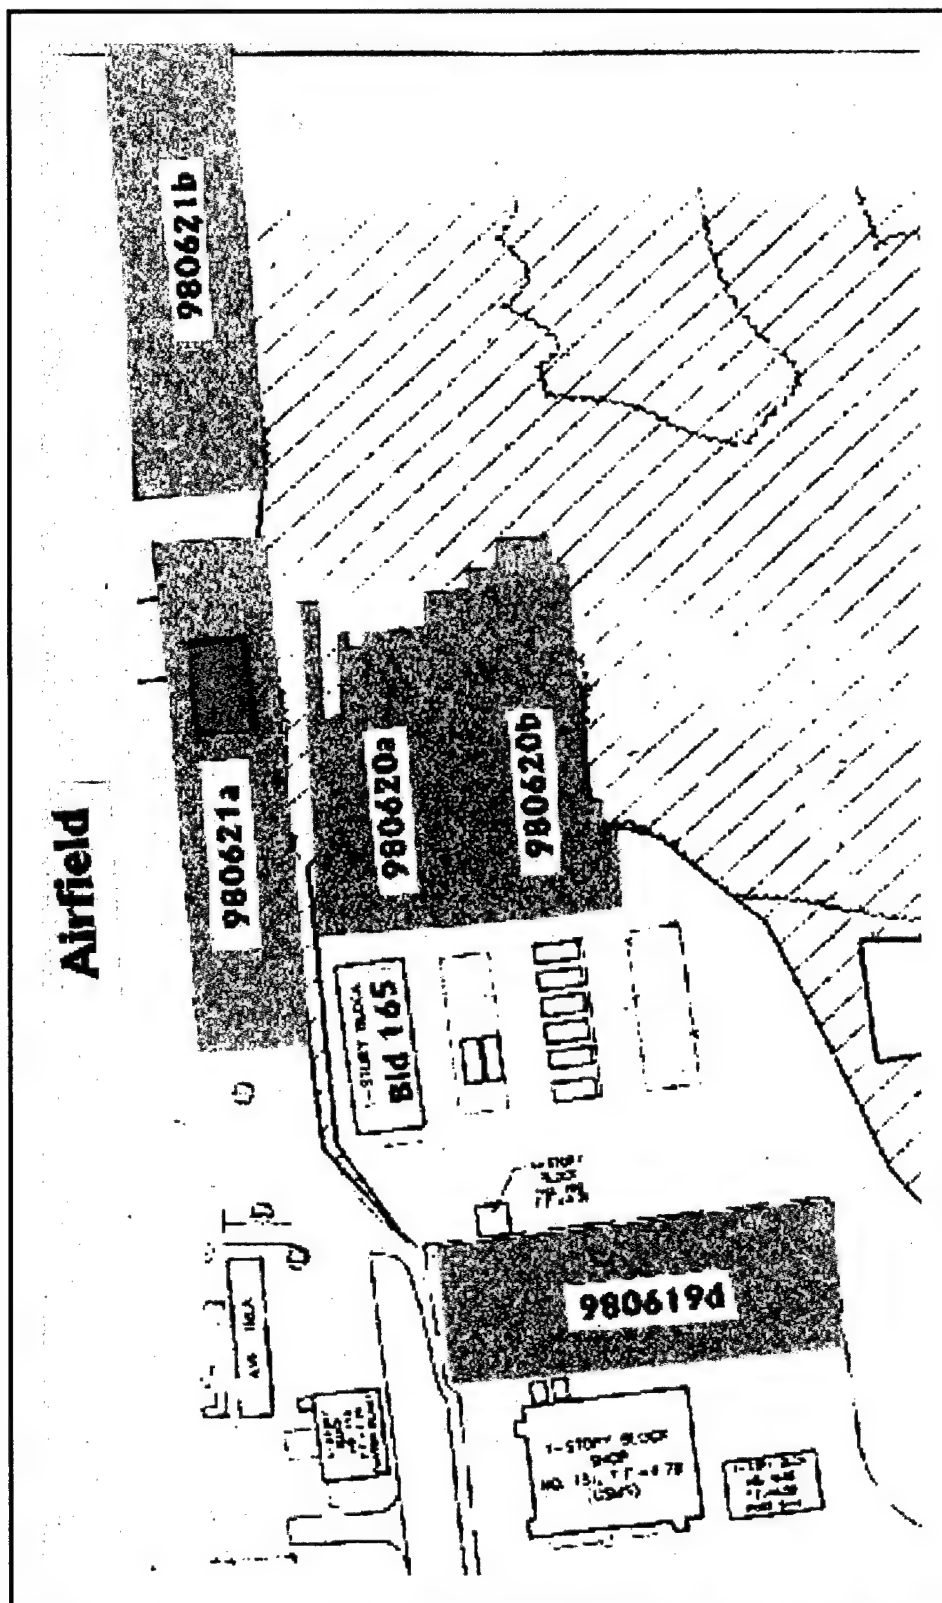
Figure 23. Electromagnetic survey locations at Bethany Beach National Guard Training Site, Bethany Beach, DE (designations in bold are data file identifiers).

The remaining survey areas are shown in Figure 23. An underground storage tank had been removed from underneath the paved area north of Building 151 and a survey was conducted to determine if another was present there. This area was surveyed using both instruments.

Most of the open area east of the airfield and an irregular area north of Building 165 was surveyed for possible presence of buried 55-gal drums. The areas adjacent to the airfield were surveyed with the GEM-300 and a small area on 980621a re-surveyed with the GEM-1. The irregular area north of Building 165 was surveyed by placing long tapes every 5 ft as far as possible into the heavily vegetated area. Thick stands of poison ivy and other plants limited the extent of the northern edge of this survey.

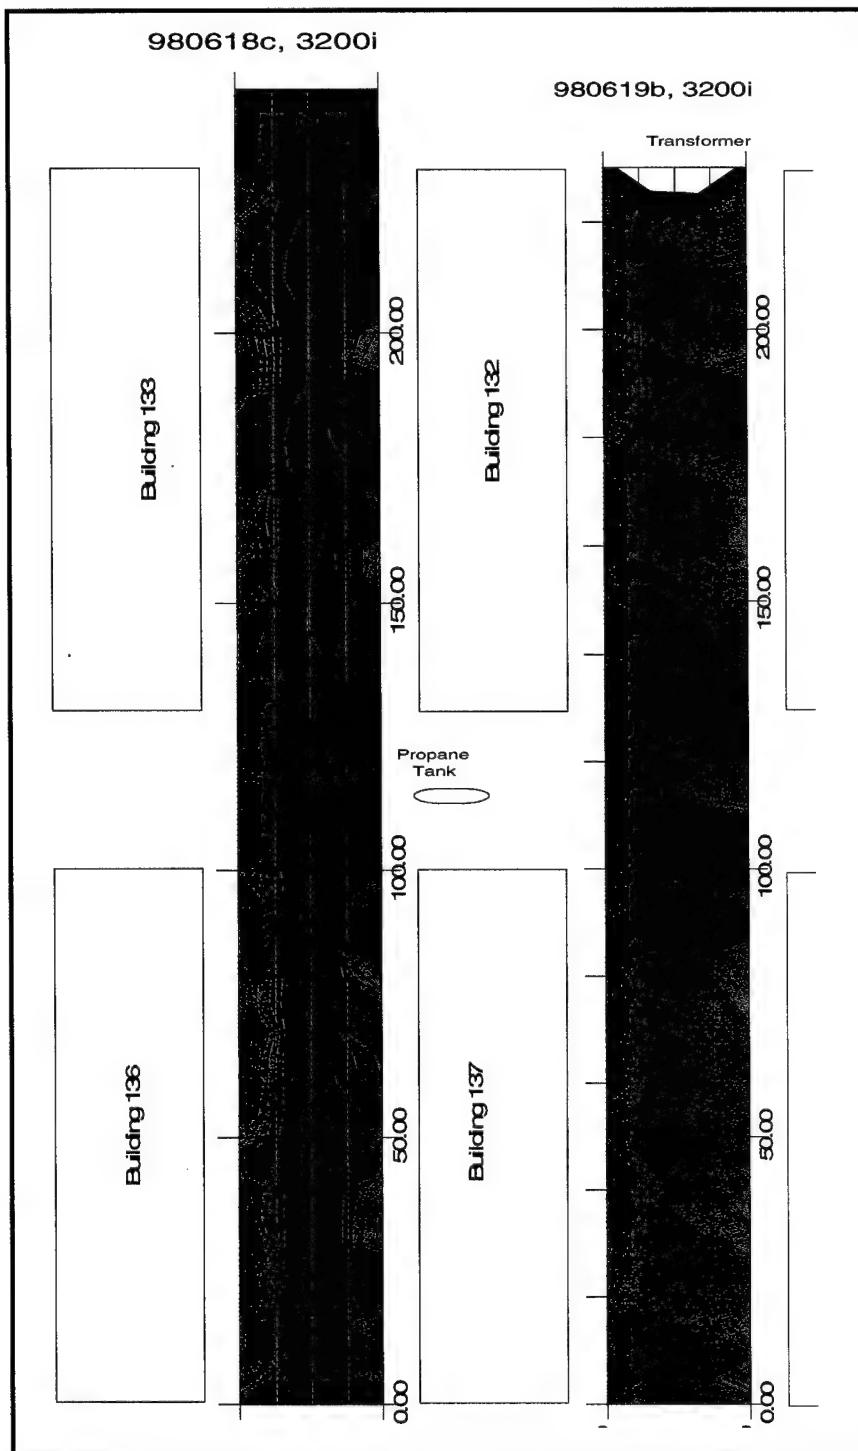
The west block (or Block 1) consists of data files 980618c between Buildings 136-137 and 133-132, and 980619b between Buildings 137-138 and 132-131. Figure 24 shows the 3200 in-phase data for these surveys in contour plots. The primary items of interest that can be identified in this data include the effects of metallic objects in the buildings along the edges of the plots. High readings caused by the presence of the propane tank area are also visible.

Figure 24. Electromagnetic survey data, Bethany Beach, DE, National Guard Training Site, Barracks area, Block 1.

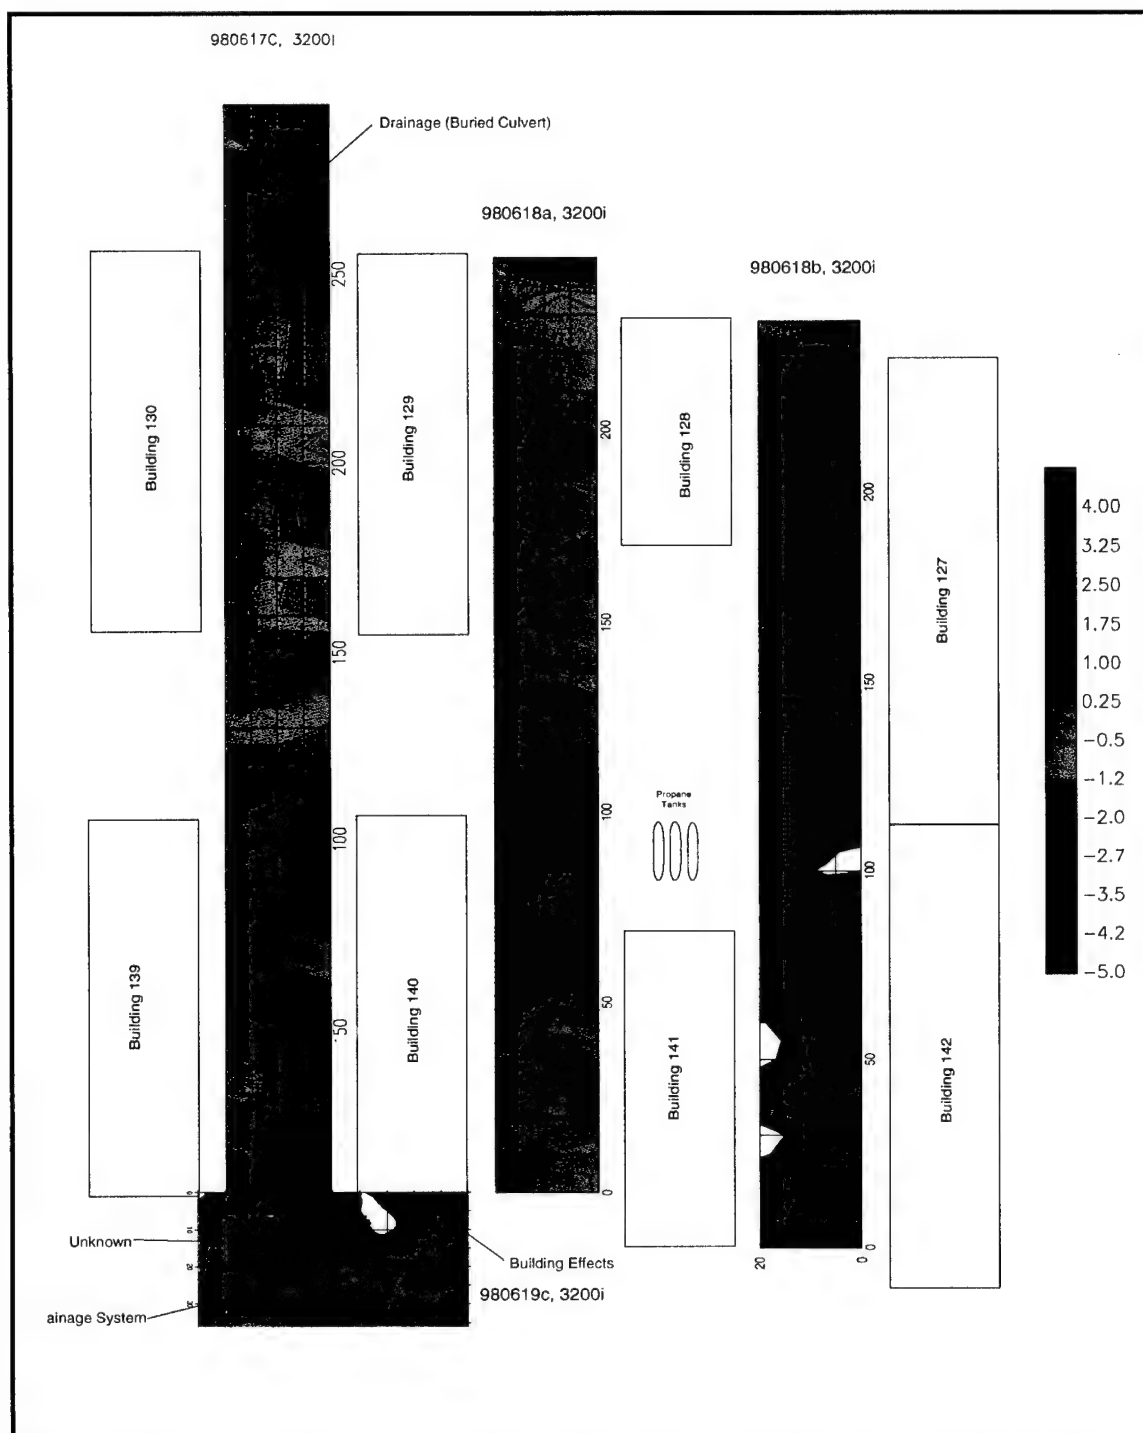
Figure 25 gives the results of the electromagnetic surveys of Block 2 in the barracks area. The plots are contour maps of the 3200 Hz, in-phase data. The data files for this block include 980617c between buildings 139-140 and 130-129, 980618a between buildings 140-141 and 129-128, 980618b between buildings 141-142 and 128-127, and 980619c at the south end of building 140, an area extending into the street. Items of interest in this data include the shallow buried culvert that is part of the storm water drainage system at the north end of the 980617c data and an unknown object that appears on the south end of this data.

An additional data set, 980619c (40 X 50 ft), was taken adjacent to the south end of 980617c to further define the size and shape of this object. Additional features that appear in this data include the manhole cover in the southeast corner, the diagonal electrical service (there is a matching pavement patch install diagonally across the paved street coincident with this) and an east-west feature under the south side of the road, which appears to be attached to the manhole and may be part of the drainage system. This data set was taken right up to Building 140; there appears to be some kind of relatively large metallic object (refrigerator or bed) in the southeast corner of this building. The unknown object first identified in 980617c does not appear to be attached to any of the other objects in this set of data (that is to say, it does not appear to be part of the drainage system). Two cast iron pipe studs extend up out of the foundation at the 100-ft point by Building 142. This is indicated as low readings at this point. The data does not indicate that the pipes are attached to any large metallic underground systems that extend into the surveyed area.

Figure 25. Electromagnetic survey data, Bethany Beach, Delaware National Guard Training Site, barracks area, Block 2.

Electromagnetic surveys of Block 2 in the barracks area, including survey 980617c, 980618a, 980618b, and 980619c indicated a shallow buried culvert that is part of the storm water drainage system at the north end of the 980617c data and an unknown object that appears on the south end of this data.

An additional data set, 980619c, included a manhole cover in the southeast corner, the diagonal electrical service, and an east-west feature under the south side of the road, which appears to be attached to the manhole and may be part of the drainage system. The unknown object first identified in 980617c does not appear to be part of the drainage system. Two cast iron pipe studs extend up out of the foundation at the 100-ft point near Building 142. The data does not indicate that the pipes are attached to any large metallic underground systems that extend into the surveyed area.

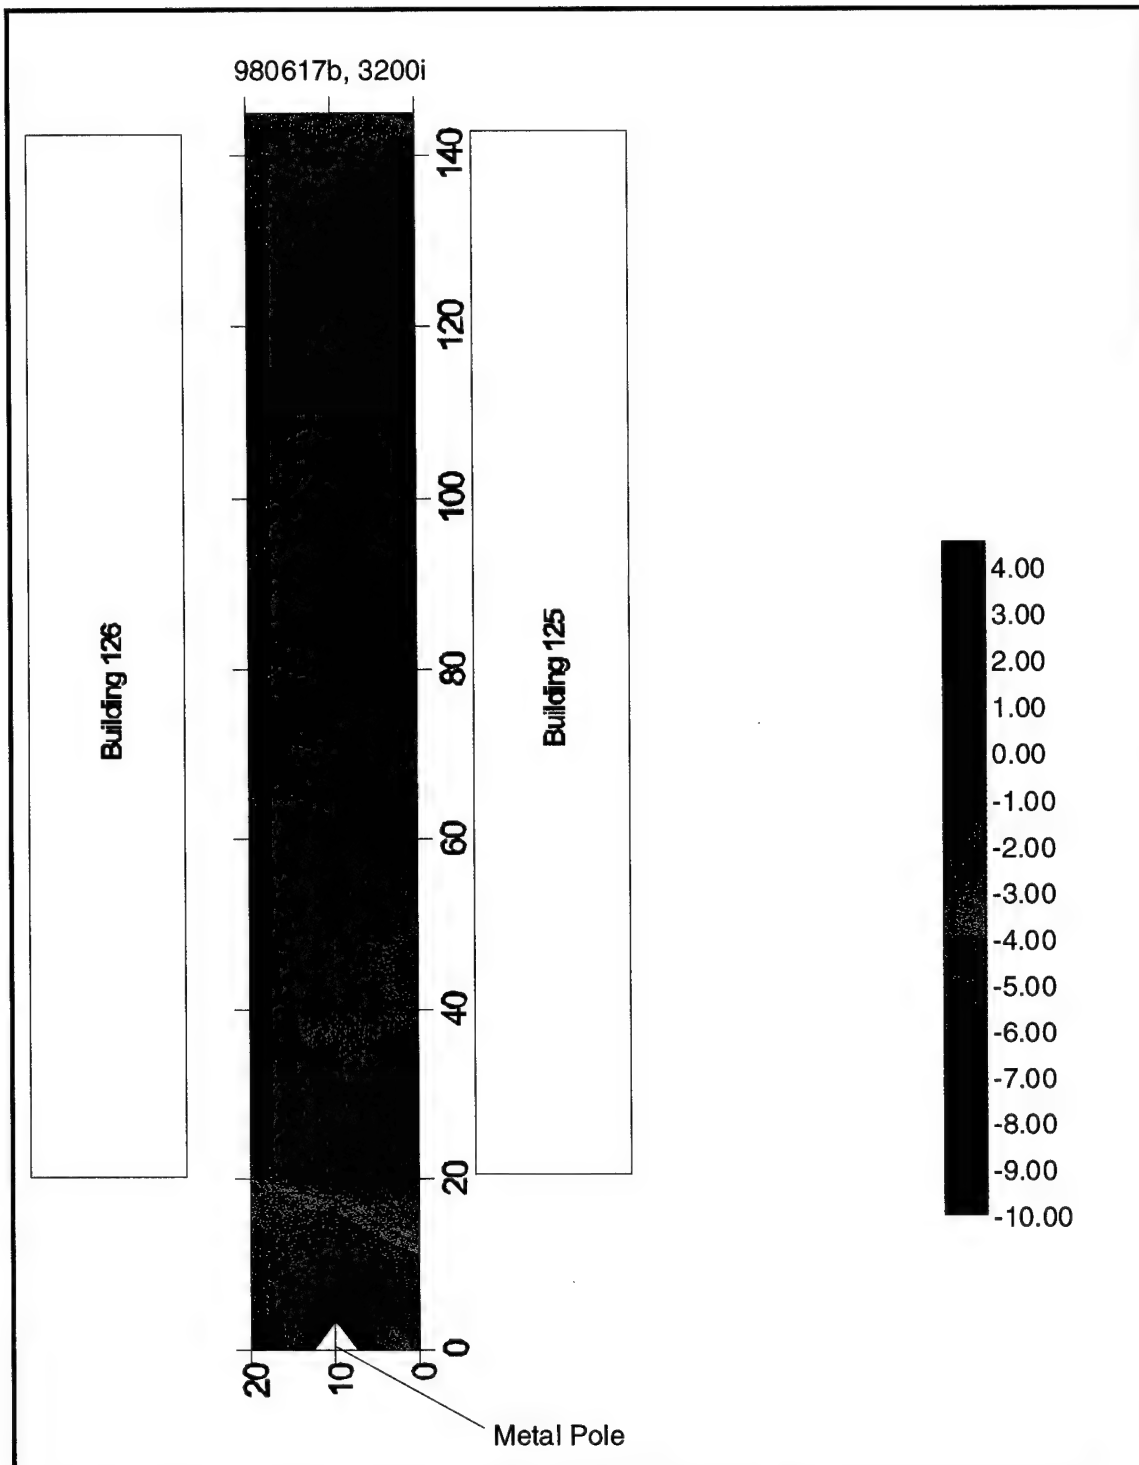
Figure 26 shows the 3200 Hz, in-phase data for 980617b taken between buildings 126-125. This plot shows some minor building effects and the effects of a metal pole in the center of the south edge of the data.

Figure 26. Electromagnetic survey data, Bethany Beach, Delaware National Guard Training Site, 980617b, 3200 Hz, in-phase data, block 3.

In-phase data for 980617b taken between buildings 126-125 show some minor building effects and the effects of a metal pole in the center of the south edge of the data.

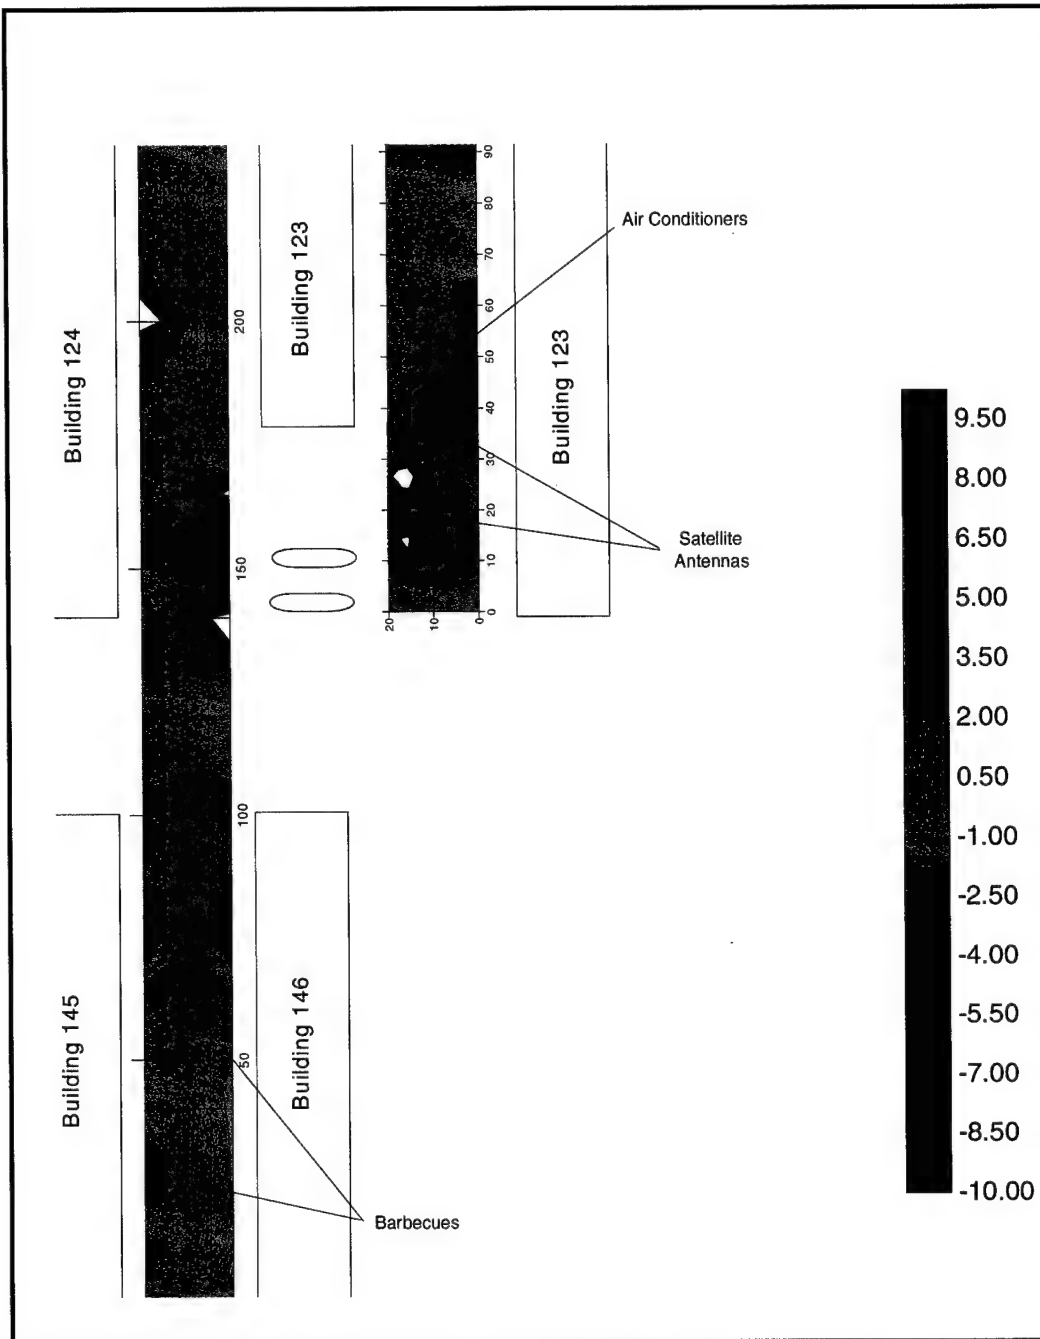
Figure 27 shows the 3200 Hz, in-phase data for the files 980619a between buildings 145-146 and 124-123, and 980618d between buildings 123-124. All the outstanding objects appearing on these plots are surface features including building effects, barbecues, propane tanks, air conditioners, and satellite antennas. No subsurface objects can be identified from this data.

Figure 27. Electromagnetic survey data, Bethany Beach, Delaware National Guard Training Site, 3200 Hz, in-phase data, block 4.

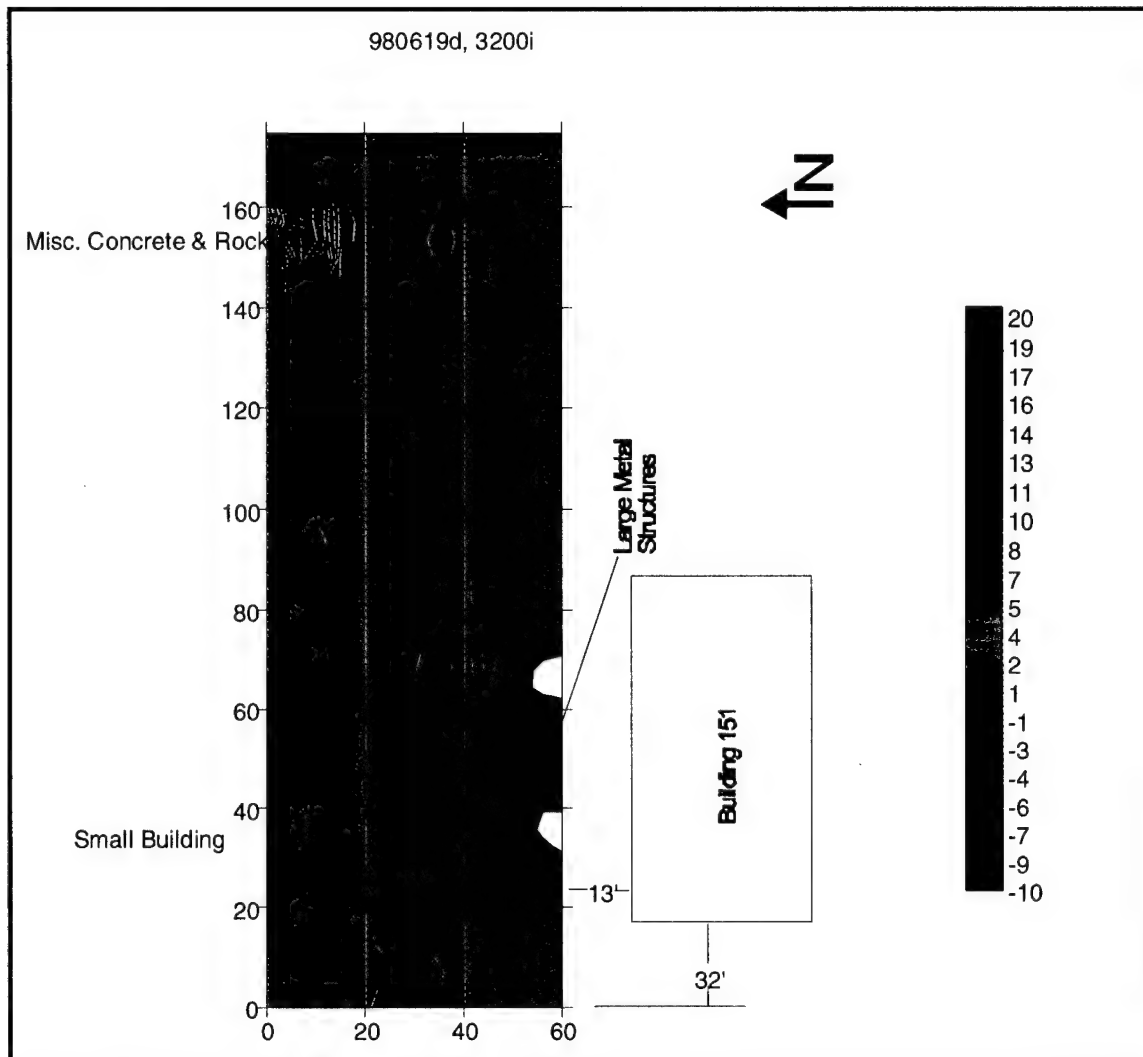
Figure 28 shows a plot of the electromagnetic survey results of the 3200 Hz, in-phase measurements of data file 980619d, a paved area north of Building 151. An underground fuel storage had been removed from this area. This survey was conducted to determine if any other objects existed elsewhere in the area. Items visible in this plot include the small storage building just to the north of the pavement between 20 and 40 ft, the miscellaneous concrete and rock pile on the northeast corner, and the large metal containers on the south side of the search area near building 151. Some of the broken concrete on the pile contained light reinforcement. No evidence of any additional buried storage tanks or other significant metal was discovered under the paved area.

Figure 28. Electromagnetic survey data, Bethany Beach National Guard Training Site, paved area north of Building 151, 3200 Hz, in-phase data.

A survey of the paved area north of Building 151 conducted as a follow-up on the removal of an underground fuel storage tank in that area showed no evidence of any additional buried storage tanks or other significant metal under the paved area. No subsurface objects were observed.

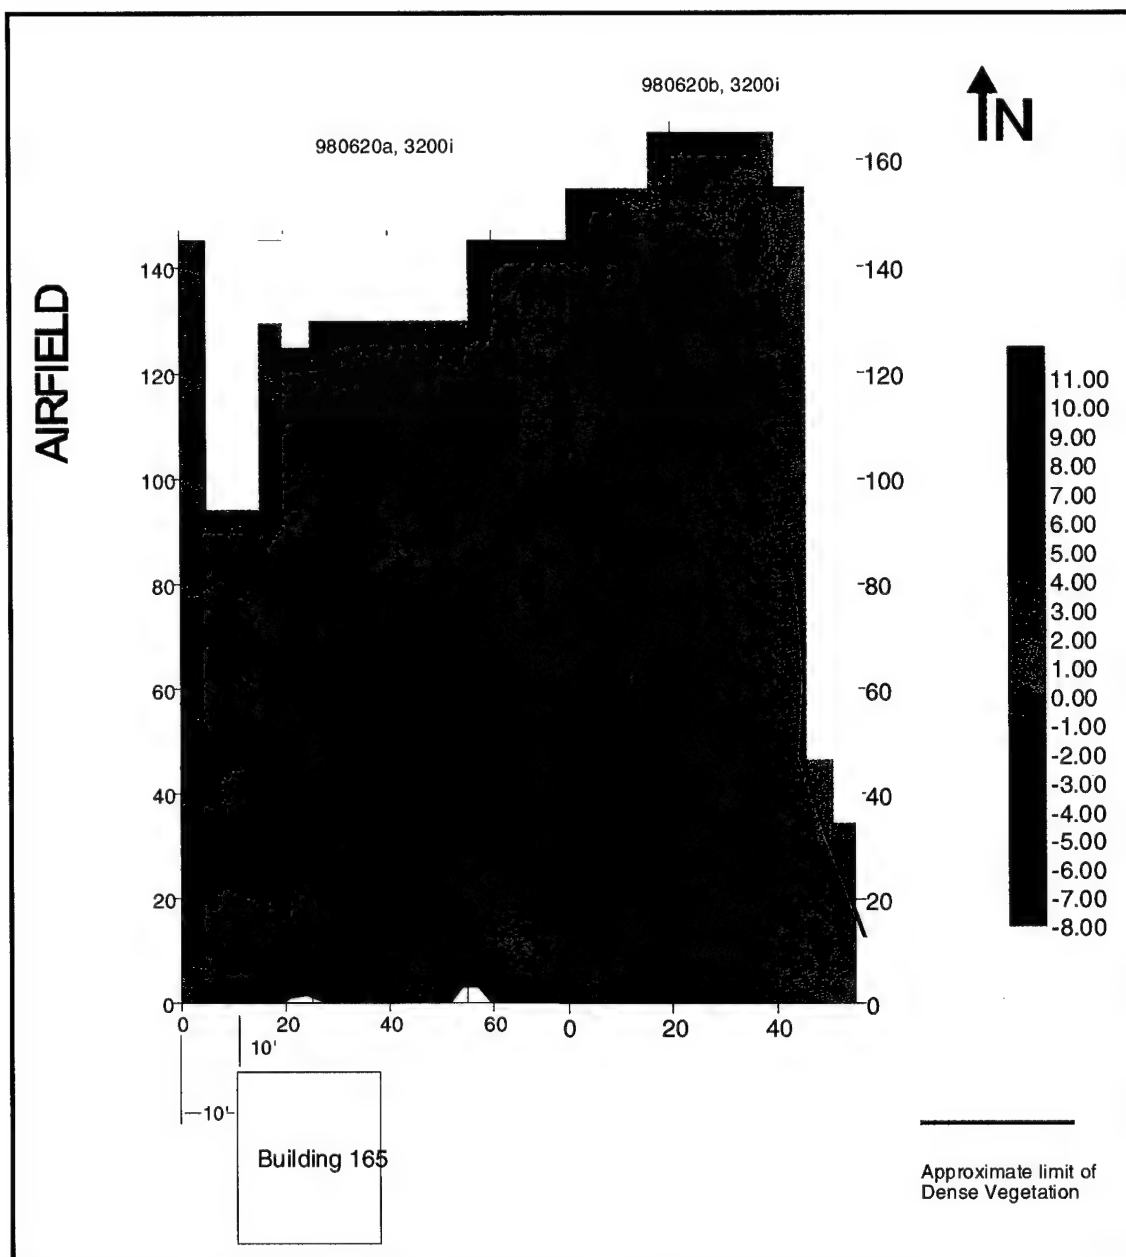
Figure 29 gives the results of the electromagnetic surveys conducted north of Building 165 on the cleared area and into the heavily vegetated area. This survey was conducted by placing tape measures on the ground with a 5-ft spacing. The tapes were carried into the vegetation a distance determined by the density of vegetation and the density of the poison ivy. Thus the lines of data are not of equal length and data point location is not as accurate as that typically expected in open areas. Some of the objects that appear on this plot are associated with broken concrete with metal reinforcement (generally heavy wire type) that was visible on the surface. Other objects were not associated with any surface articles. The spacing and configuration of the findings in this area are typical of landfills. No significant objects were found in the open (grassy) area covered in this search.

Figure 29. Electromagnetic survey data, Bethany Beach National Guard Training Site, area north of Building 165, 3200 Hz, in-phase data.

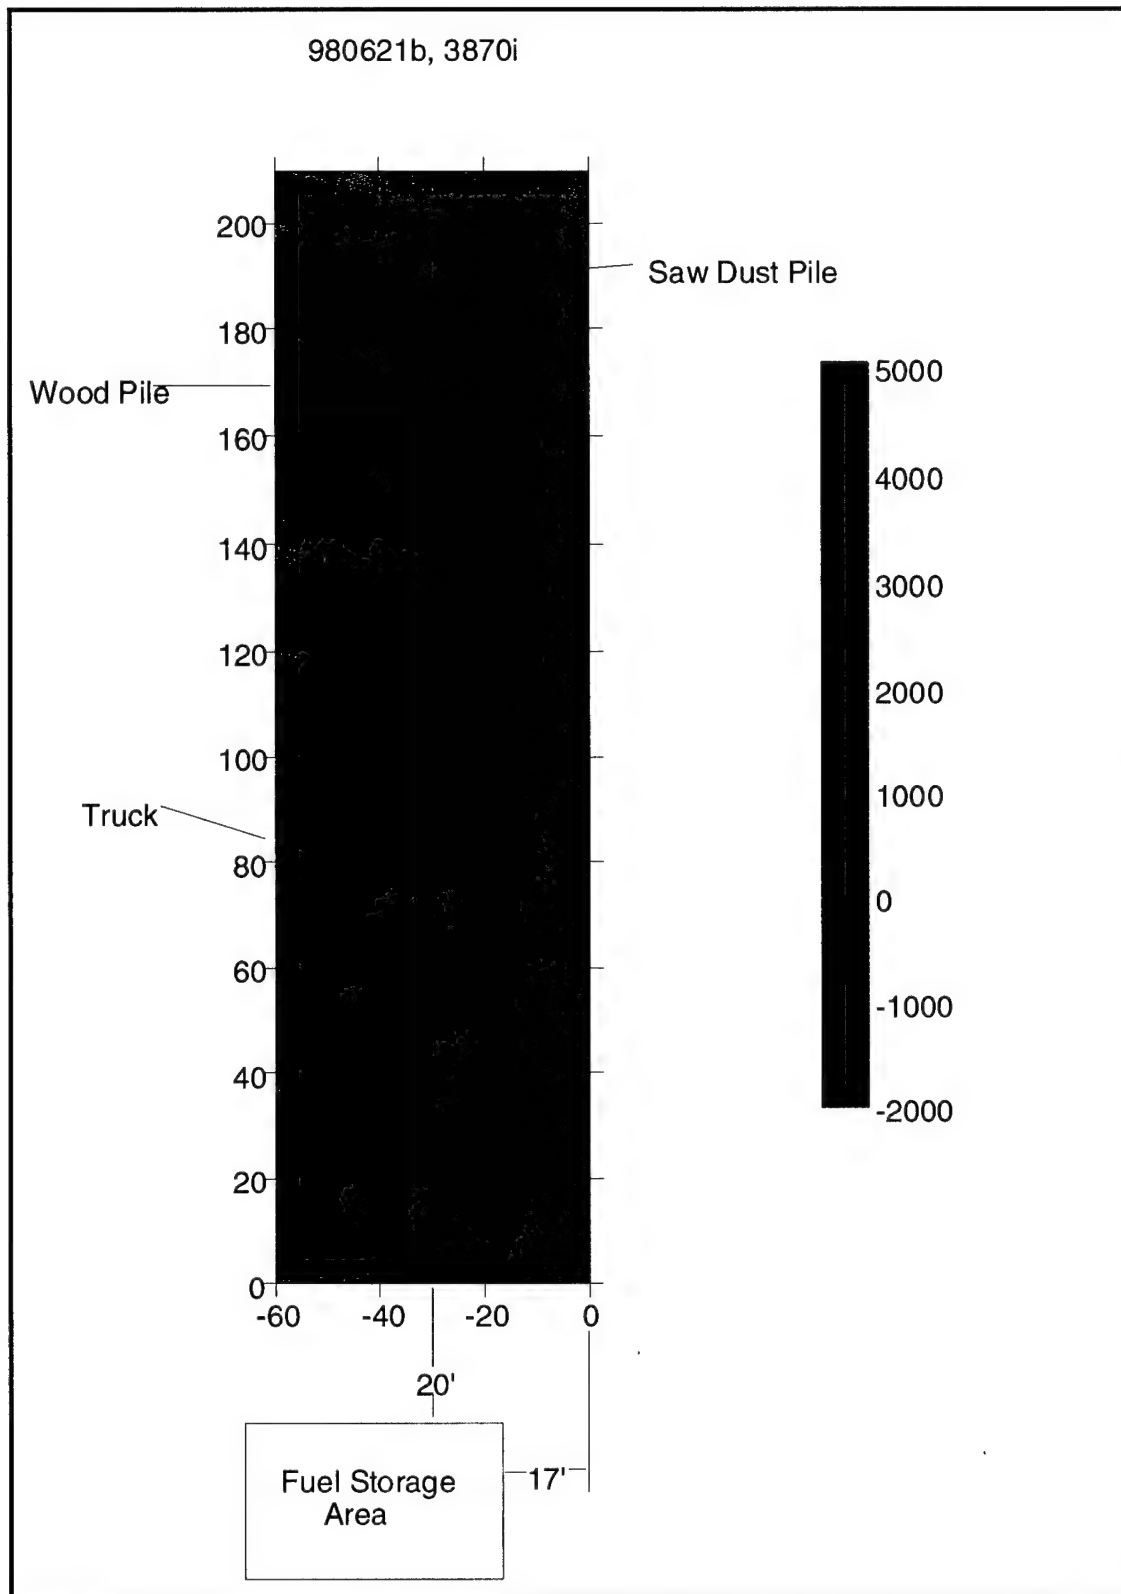
The Pennsylvania Air National Guard was using the landing strip for training during the period the surveys were being conducted and not all of the area to the east of the runway was available to be surveyed. However a strip 50 ft wide and 235 ft long south of the fuel storage area and a strip 60 ft wide and 210 ft long north of the fuel storage area were free of vehicles. These areas were surveyed with the GEM-300. Figure 30 gives the results of the north survey at 3870 Hz, in phase.

The objects of interest in this plot are effects from the National Guard trucks parked near the search area and high readings associated with the waste wood pile near the north end of the search area. No subsurface objects were observed.

Figure 30. Electromagnetic survey data, Bethany Beach, Delaware National Guard Training Site, area near air field, 3870 Hz, in-phase data.

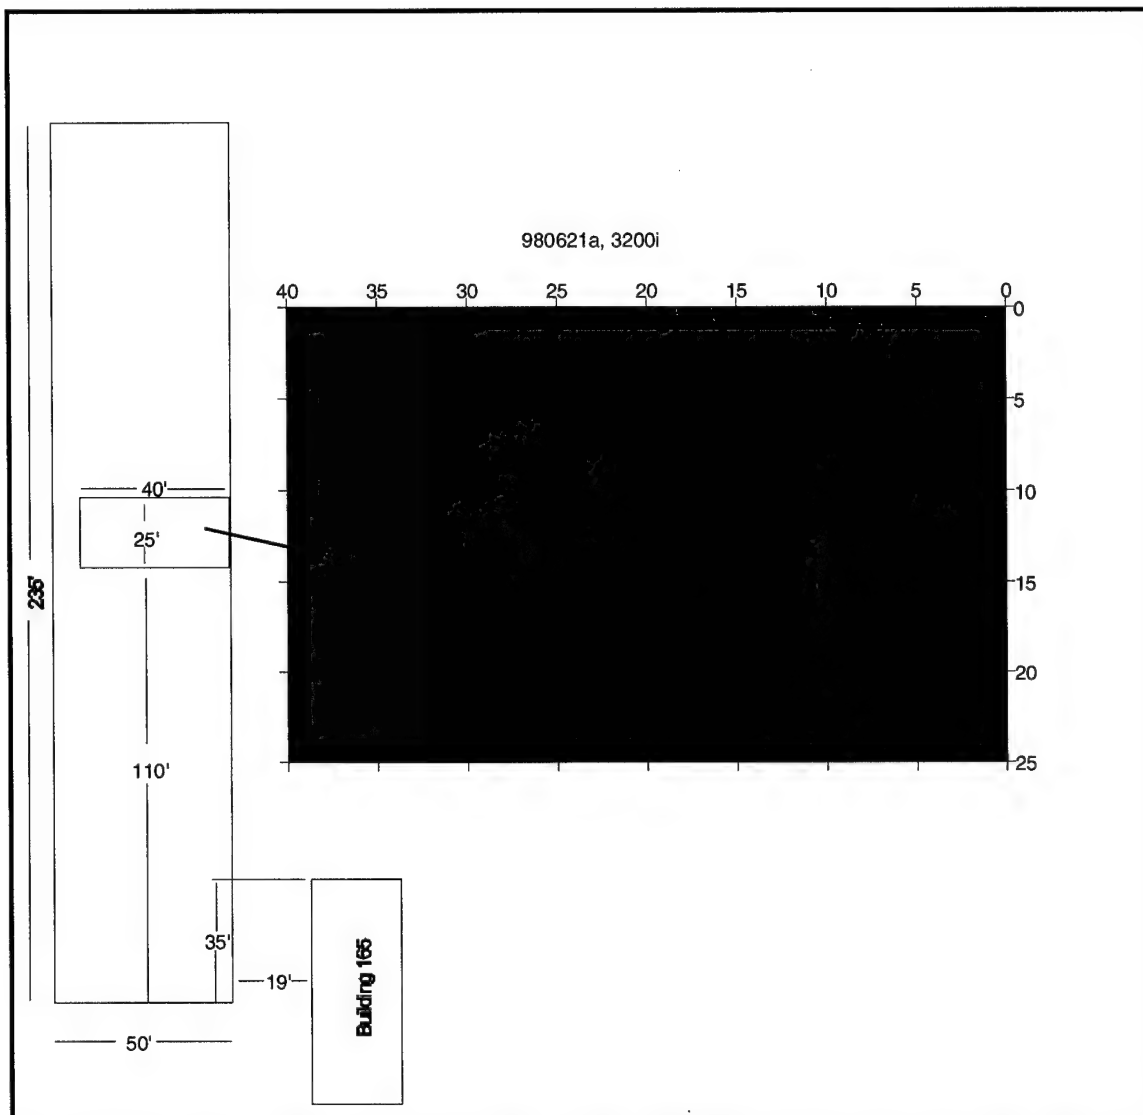
The GEM-300 data file for the 50 X 235 ft area to the south of the fuel storage area was not saved due to technical problems and only one possible subsurface object was identified. A smaller area containing this unknown was re-surveyed with the GEM-1. Figure 31 shows the survey results. The previously identified object is probably a relatively small shallow metal object located relatively near the location shown on the plot.

Figure 31. Electromagnetic survey data, Bethany Beach, Delaware National Guard Training Site, area near air field, 3200 Hz, in-phase data.

The major problems related to surveying this area are setting up an accurate search grid, accurate positioning of the sensor for collecting data, and transporting the sensor through the area. It is recommended that any further (or follow-up) surveys in this area be conducted in the winter after the leaves of the poison ivy and any other deciduous plants have fallen.
